**Flood Control Project Maintenance
Levee Inspections**

Fall 2015 Levee Maintenance Deficiency Summary Report

San Joaquin River Basin

Reclamation District No. 2107 Mossdale Island

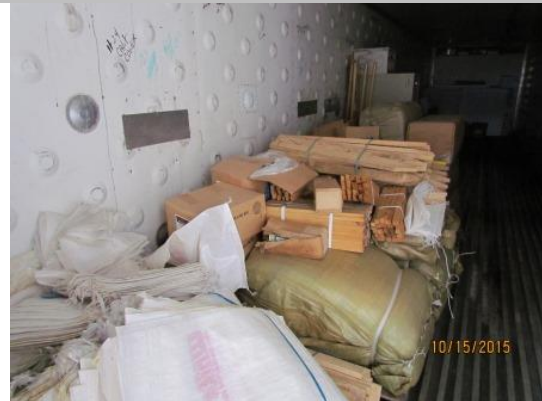
Photo 1 of 1 : FA_2015_RD2107_329_7_20151026_00015.jpg

LM Start		Rating **	A	Issue No.	7		
LM End		Issue Type +	Ma	Location *	CR		
Category	Earthen Levee			GPS Latitude/Longitude			
				Start		End	
Item	Emergency Supplies & Equipment				°		°
					°		°
DWR ID	DWR_RD2107_01_s _ 2013_7						
Action/Comments							
Inspector Comments: Flood fighting supplies are available on-site.

View of the flood fight emergency supplies.

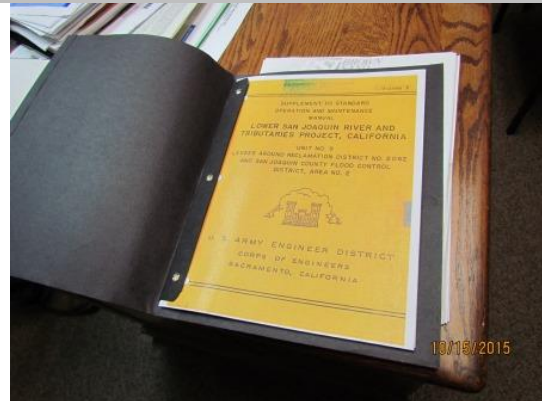
Photo 1 of 1 : FA_2015_RD2107_329_8_20151026_00016.jpg

LM Start		Rating **	A	Issue No.	8	
LM End		Issue Type +	Ma	Location *	CR	
Category	Earthen Levee			GPS Latitude/Longitude		
				Start		End
Item	Operations & Maintenance Manuals				o	
					o	
DWR ID	DWR_RD2107_01_s _ 2013_8					
Action/Comments						
Inspector Comments: The O&M Manual is available at the LMA's office.

View of the O&M Manual.

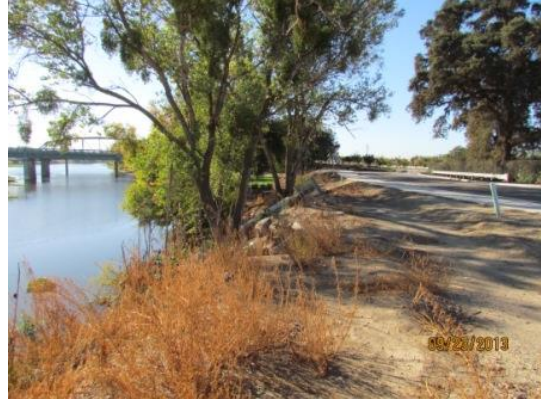
Photo 1 of 1 : FA_2015_RD2107_329_1_20150910_00001.jpg

LM Start	0.03	Rating **	N	Issue No.	1
LM End	0.03	Issue Type +	Ma	Location *	WS
Category	Earthen Levee			GPS Latitude/Longitude	
				Start	End
Item	Trim / Thin Trees			37.786993 °	37.786993 °
				-121.308694 °	-121.308694 °
DWR ID	DWR_RD2107_01_s _ 2012_1				
Action/Comments					
Tree stumps.

Photo of waterside slope. Stumps present from prior tree removal for access and visibility.

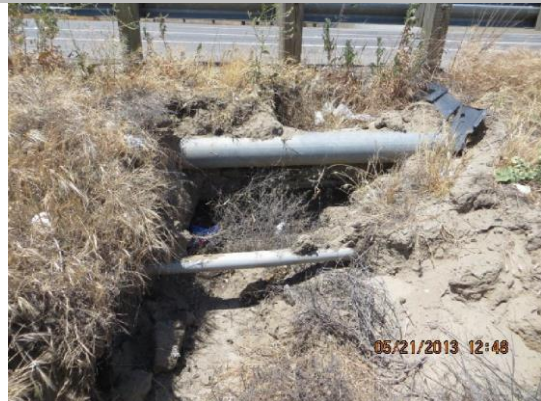
Photo 1 of 1 : UCIP_FA_2015_0880.jpg

LM Start	0.23	Rating **	M	Issue No.	58
LM End	0.23	Issue Type +	En	Location *	WS
Category	Supplemental			GPS Latitude/Longitude	
				Start	End
Item	DWR UCIP Field Study			37.784586 °	37.784586 °
				-121.306837 °	-121.306837 °
DWR ID					
Action/Comments					
Inspector Comments: FS_ID:15175 DS_ID:23108 EP_NO: N/A FS_HLM: 0.232 Repair Type: Non-Urgent Crossing Status: Found UCIP Comments: No permit identified. Erosion exposed pipes on LS. FIELD_STRUCT_DESC: 8-inch steel conduit 1-foot below the road surface within roadway fill over levee crown. Visible on Upstream side of bridge. FS Date: 05/22/2013

Pipes visible on LS next to roadway.

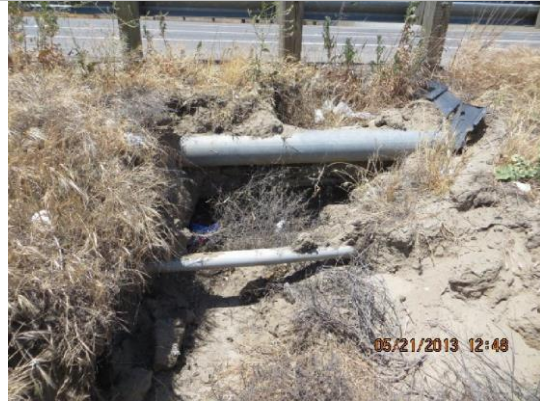
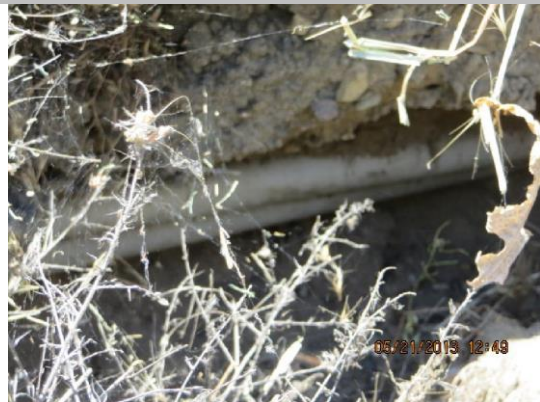
LM Start	0.23	Rating **	M	Issue No.	59
LM End	0.23	Issue Type +	En	Location *	WS
Category	Supplemental			GPS Latitude/Longitude	
				Start	End
Item	DWR UCIP Field Study			37.784586 °	37.784586 °
				-121.306837 °	-121.306837 °
DWR ID					
Action/Comments					
Inspector Comments: FS_ID:15174					
DS_ID:23110					
EP_NO: N/A					
FS_HLM: 0.232					
Repair Type: Non-Urgent					
Crossing Status: Found					
UCIP Comments: No permit identified for this crossing.					
FIELD_STRUCT_DESC: 1.5-inch PVC conduit 1-foot below the road surface within roadway fill over levee crown.					
FS Date: 05/22/2013

Pipes visible on LS next to roadway.

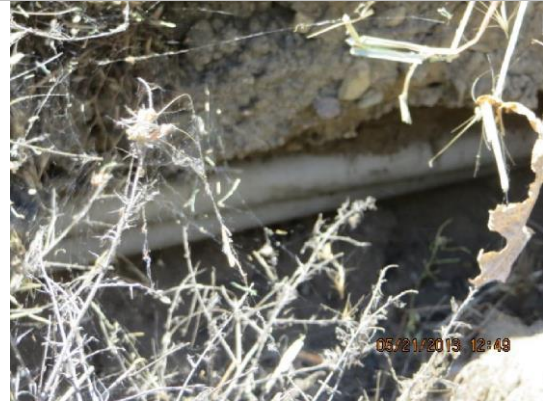
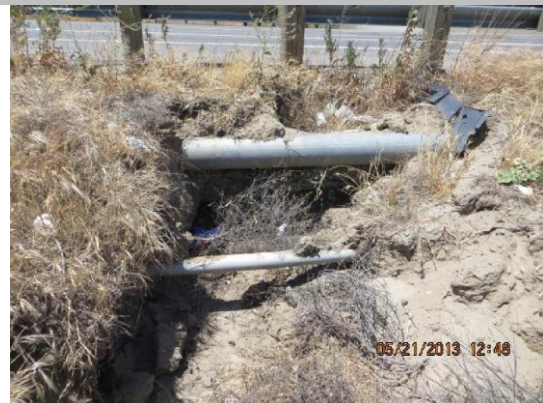
LM Start	0.23	Rating **	M	Issue No.	60
LM End	0.23	Issue Type +	En	Location *	WS
Category	Supplemental			GPS Latitude/Longitude	
				Start	End
Item	DWR UCIP Field Study			37.784586 °	37.784586 °
				-121.306837 °	-121.306837 °
DWR ID					
Action/Comments					
Inspector Comments: FS_ID:15173					
DS_ID:23109					
EP_NO: N/A					
FS_HLM: 0.232					
Repair Type: Non-Urgent					
Crossing Status: Found

Pipes visible on LS next to roadway.

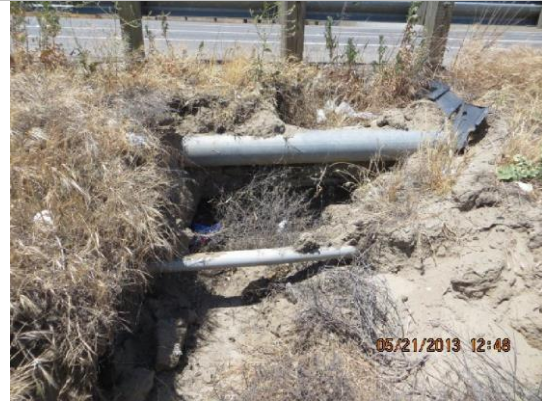
Photo 1 of 1 : UCIP_FA_2015_1405.jpg

LM Start	0.23	Rating **	M	Issue No.	61
LM End	0.23	Issue Type +	En	Location *	WS
Category	Supplemental			GPS Latitude/Longitude	
				Start	End
Item	DWR UCIP Field Study			37.784586 °	37.784586 °
				-121.306837 °	-121.306837 °
DWR ID					
Action/Comments					
Inspector Comments: FS_ID:16187					
DS_ID:23107					
EP_NO: N/A					
FS_HLM: 0.232					
Repair Type: Non-Urgent					
Crossing Status: Found

Pipes visible on LS next to roadway.

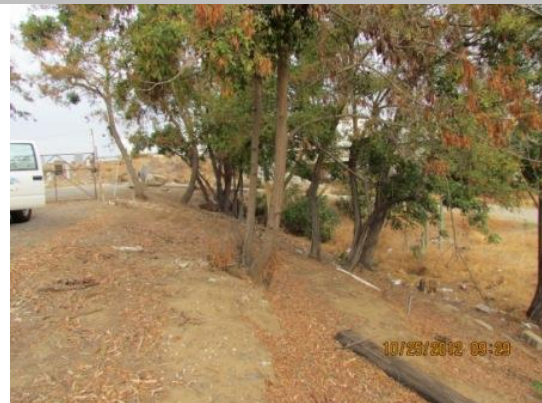
Photo 1 of 1 : FA_2015_RD2107_329_2_20150910_00002.jpg

LM Start	0.26	Rating **	N	Issue No.	2
LM End	0.26	Issue Type +	Ma	Location *	WS
Category	Earthen Levee			GPS Latitude/Longitude	
				Start	End
Item	Trim / Thin Trees			37.784316 °	37.784316 °
				-121.306498 °	-121.306498 °
DWR ID	DWR_RD2107_01_s_2012_2				
Action/Comments					
Tree stumps.

Tree stumps present on slope. They were left from prior vegetation removal for access and visibility.

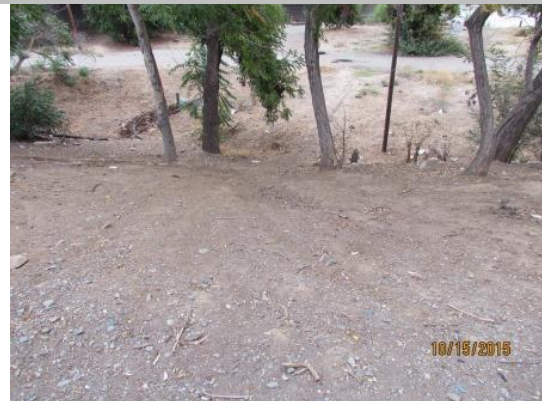
Photo 1 of 1 : FA_2015_RD2107_329_19_20151026_00011.jpg

LM Start	0.26	Rating **	M	Issue No.	19
LM End	0.26	Issue Type +	Ma	Location *	WS
Category	Earthen Levee			GPS Latitude/Longitude	
				Start	End
Item	Slope Stability			37.784300 °	37.784300 °
				-121.306488 °	-121.306488 °
DWR ID	DWR_RD2107_01_f_2015_19				
Action/Comments					
Repair the levee slope damaged by foot traffic and prevent access where possible.

View of the tracks on the waterside levee slope.

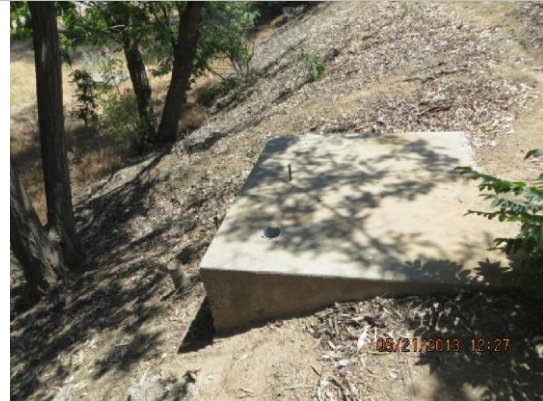
Photo 1 of 1 : UCIP_FA_2015_1406.jpg

LM Start	0.27	Rating **	M	Issue No.	62
LM End	0.27	Issue Type +	En	Location *	WS
Category	Supplemental			GPS Latitude/Longitude	
				Start	End
Item	DWR UCIP Field Study			37.784194 °	37.784194 °
				-121.306353 °	-121.306353 °
DWR ID					
Action/Comments					
Inspector Comments: FS_ID:16188 DS_ID:19055 EP_NO: 12101B FS_HLM: 0.27 Repair Type: Non-Urgent Crossing Status: Found UCIP Comments: Appears abandoned and should be done so properly. FIELD_STRUCT_DESC: 4" electrical conduit through the levee 2.5 feet below the crown. Distribution panel on a 5-foot by 6-foot concrete pad on the WS shoulder (Permit No 12101B, 1979). FS Date: 05/21/2013

5X5 concrete pad with exposed electrical conduit on WS shoulder.

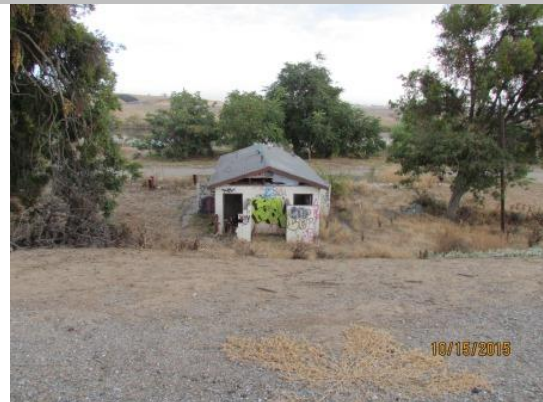
Photo 1 of 1 : FA_2015_RD2107_329_20_20151026_00012.jpg

LM Start	0.32	Rating **	M	Issue No.	20
LM End	0.32	Issue Type +	En	Location *	WS
Category	Earthen Levee			GPS Latitude/Longitude	
				Start	End
Item	Encroachments			37.783649 °	37.783649 °
				-121.305710 °	-121.305710 °
DWR ID	DWR_RD2107_01_f_2015_20				
Action/Comments					
Building Inspector Comments: Building in the floodway may impede flood flows.

View of the building in the floodway.

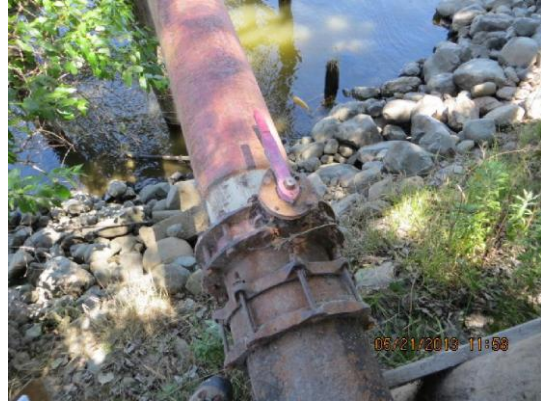
Photo 1 of 3 : UCIP_FA_2015_0457.jpg

Inspector Comments: FS_ID:13684
 DS_ID:19036
 EP_NO: N/A
 FS_HLM: 0.684
 Repair Type: Non-Urgent
 Crossing Status: Found
 UCIP Comments: Wooden walkway to pump on platform is in disrepair and may be a hazard.
 FIELD_STRUCT_DESC: 1 of 2: 14-inch pipe through the levee 17.0 feet below the crown. Pump on pile structure in the stream. Walkway to pump. Slide gate in 48-inch CMP riser on WS shoulder. 36-inch concrete standpipe at the landward toe. Service pole and circuit panel on landward toe. Originally included in O&M manual, 1964.
 FS Date: 05/21/2013

Butterfly valve on WS toe.

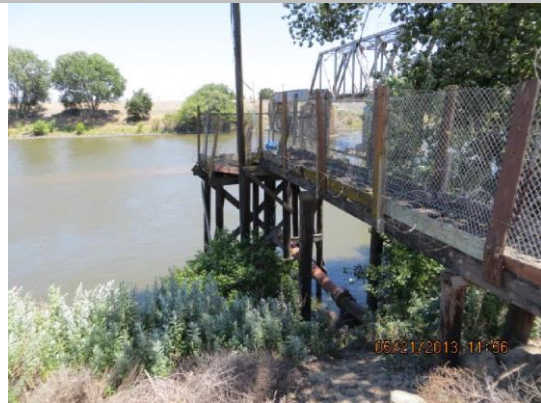
Photo 2 of 3 : UCIP_FA_2015_0458.jpg

Walkway to pump on pier at WS.

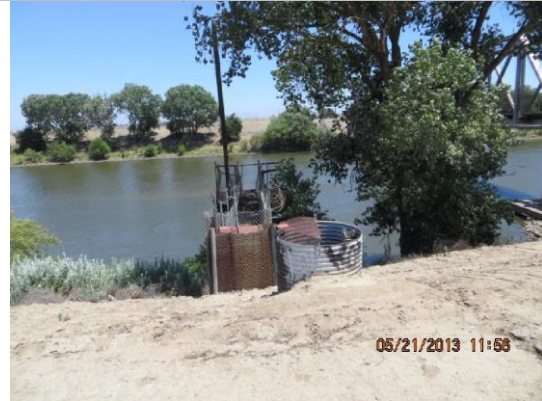
Photo 3 of 3 : UCIP_FA_2015_0459.jpg

Pier and 48-inch CMP riser on WS shoulder

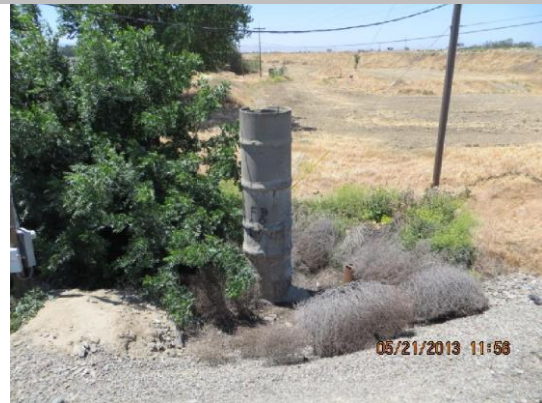
Photo 1 of 2 : UCIP_FA_2015_1148.jpg

LM Start	0.70	Rating **	M	Issue No.	64
LM End	0.70	Issue Type +	En	Location *	WS
Category	Supplemental			GPS Latitude/Longitude	
				Start	End
Item	DWR UCIP Field Study			37.779209 °	37.779209 °
				-121.301973 °	-121.301973 °
DWR ID					
Action/Comments					
Inspector Comments: FS_ID:13883					
DS_ID:19039					
EP_NO: N/A					
FS_HLM: 0.704					
Repair Type: Non-Urgent					
Crossing Status: Found					
UCIP Comments: Slide gate missing actuator inside 55-inch CMP riser.					
FIELD_STRUCT_DESC: 14-inch pipe through the levee, 15.0 feet					
below the crown. Pipe likely runs from 36-inch concrete standpipe on					
LS to outlet on WS toe. Portion of the discharge line from the pump at					
Levee Mile 0.68. 55-inch CMP riser with slide gate on LS shoulder.					
Originally included in O&M manual, 1964.					
FS Date: 05/21/2013

36-inch concrete standpipe on LS toe.

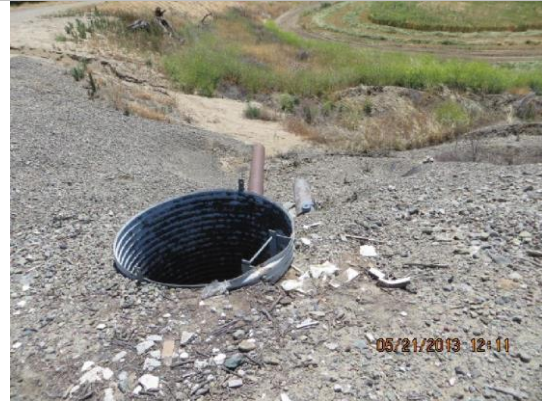
Photo 2 of 2 : UCIP_FA_2015_1149.jpg

LM Start	0.70	Rating **	M	Issue No.	64 (cont)	
LM End	0.70	Issue Type +	En	Location *	WS	
Category	Supplemental			GPS Latitude/Longitude		
				Start	End	
Item	DWR UCIP Field Study			37.779209 °	37.779209 °	
				-121.301973 °	-121.301973 °	
DWR ID						
Action/Comments						
Inspector Comments: FS_ID:13883						
DS_ID:19039						
EP_NO: N/A						
FS_HLM: 0.704						
Repair Type: Non-Urgent						
Crossing Status: Found						
UCIP Comments: Slide gate missing actuator inside 55-inch CMP riser.						
FIELD_STRUCT_DESC: 14-inch pipe through the levee, 15.0 feet						
below the crown. Pipe likely runs from 36-inch concrete standpipe on						
LS to outlet on WS toe. Portion of the discharge line from the pump at						
Levee Mile 0.68. 55-inch CMP riser with slide gate on LS shoulder.						
Originally included in O&M manual, 1964.						
FS Date: 05/21/2013

55-inch CMP riser with slide gate (no handle) on LS shoulder. 14-inch and 12-inch pipe visible on LS toe.

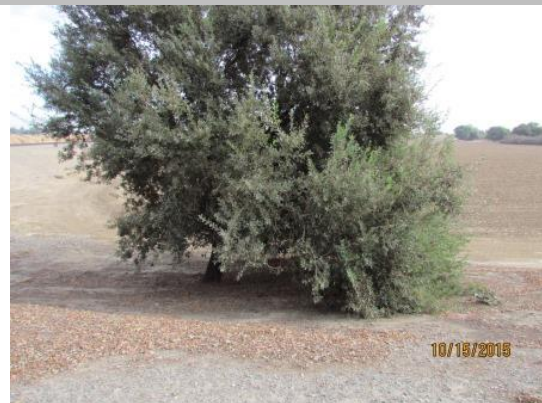
Photo 1 of 1 : FA_2015_RD2107_329_21_20151026_00013.jpg

LM Start	1.14	Rating **	M	Issue No.	21
LM End	1.14	Issue Type +	Ma	Location *	WS
Category	Earthen Levee			GPS Latitude/Longitude	
				Start	End
Item	Trim / Thin Trees			37.775324 °	37.775324 °
				-121.307685 °	-121.307685 °
DWR ID	DWR_RD2107_01_f_2015_21				
Action/Comments					
Trim trees to at least five feet above ground level.					
Inspector Comments: Trim up limbs blocking visibility.

View of the overgrown tree on the waterside levee slope obstructing visibility.

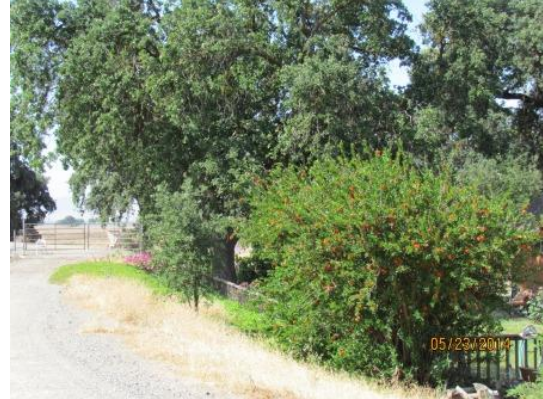
Photo 1 of 1 : FA_2015_RD2107_329_17_20150910_00004.jpg

View of landscape planting on landside levee slope and a 3-ft yard fence at the levee toe.

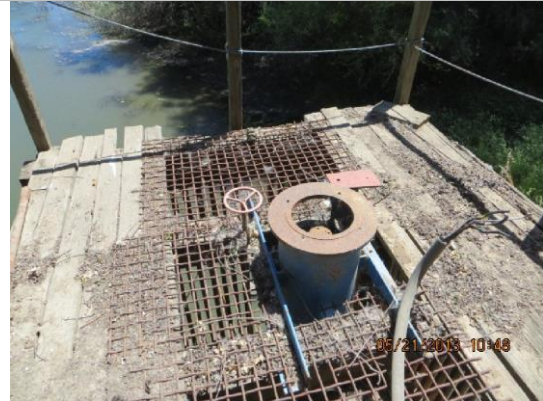
Photo 1 of 3 : UCIP_FA_2015_0660.jpg

Inspector Comments: FS_ID:15179
 DS_ID:23106
 EP_NO: N/A
 FS_HLM: 1.482
 Repair Type: Non-Urgent
 Crossing Status: Found
 UCIP Comments: Pipe open on WS toe at the pump on pier. Pipe abandoned and should be done so properly.
 FIELD_STRUCT_DESC: 16-inch steel irrigation pipe through the levee 2.5 feet below the crown. Pump on pile structure in the stream.
 Walkway to the pump.
 FS Date: 05/21/2013

Pipe open at pump on platform on WS.

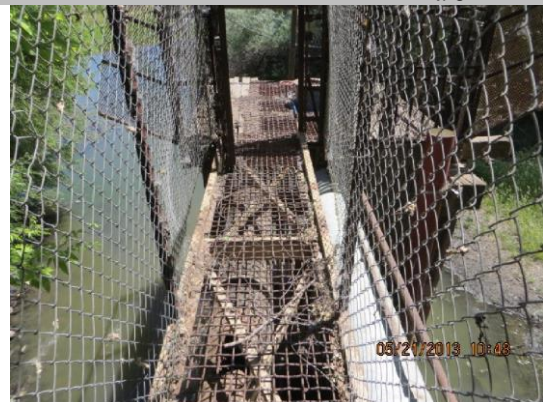
Photo 2 of 3 : UCIP_FA_2015_0661.jpg

Pipe visible under metal walkway on WS slope.

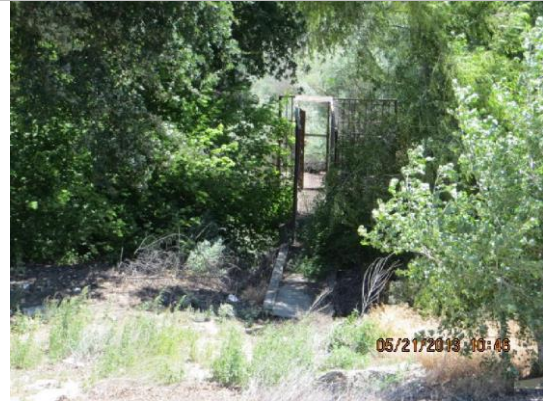
Photo 3 of 3 : UCIP_FA_2015_0662.jpg

Metal pier on WS slope.

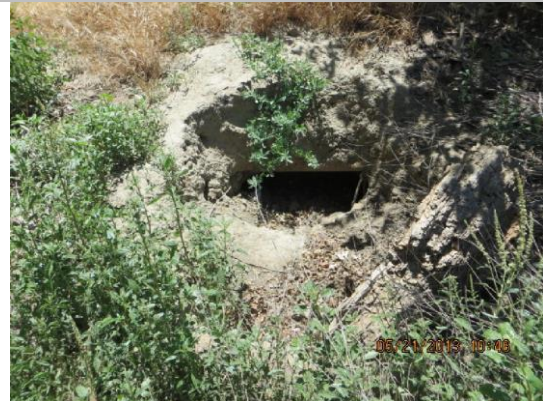
Photo 1 of 3 : UCIP_FA_2015_0171.jpg

Large hole under pipe on WS slope.

Inspector Comments: FS_ID:13650
 DS_ID:19040
 EP_NO: N/A
 FS_HLM: 1.482
 Repair Type: Non-Urgent
 Crossing Status: Found
 UCIP Comments: No pump. Appears abandoned. Large hole under pipe on WS slope from animal activity.
 FIELD_STRUCT_DESC: 1 of 2: 18-inch PVC irrigation pipe through the levee 2.5 feet below the crown. Pump on pile structure in the stream.
 Walkway to the pump. Originally included O&M manual, 1964.
 FS Date: 05/21/2013

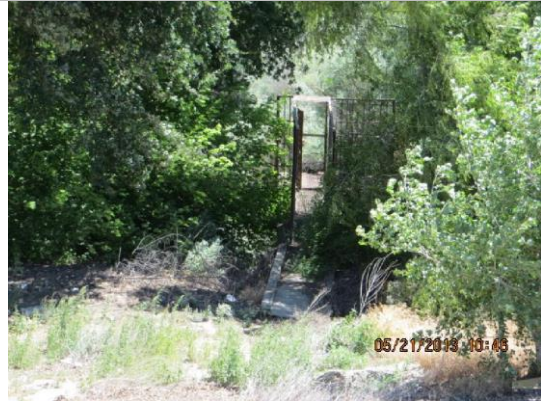
Photo 2 of 3 : UCIP_FA_2015_0172.jpg

Pumping plant on metal pier on WS toe.

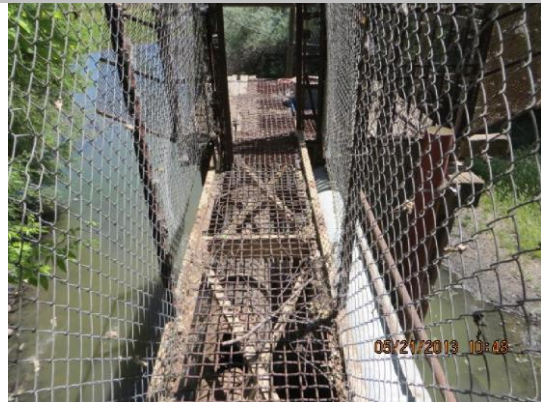
Photo 3 of 3 : UCIP_FA_2015_0495.jpg

Pumping plant on metal pier on WS toe. Pipe visible on right under walkway.

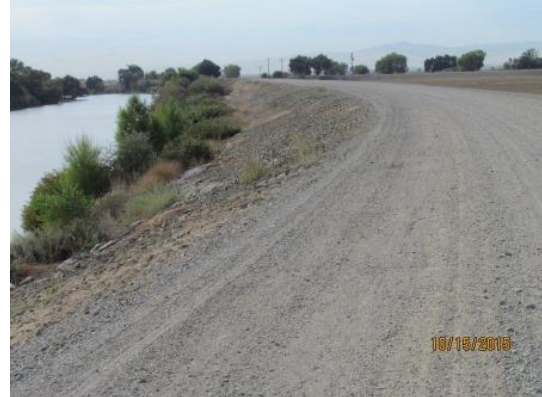
Photo 1 of 1 : FA_2015_RD2107_329_22_20151026_00014.jpg

View of the acceptable vegetation on the waterside levee slope.

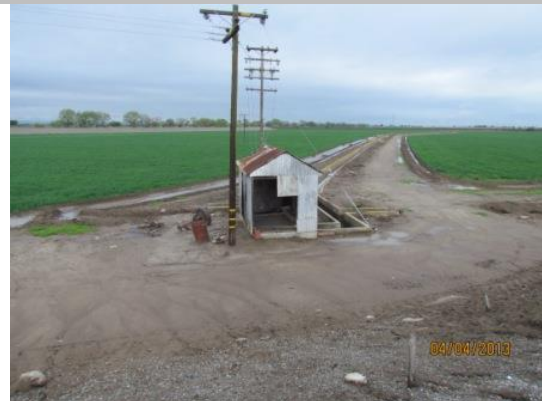
Photo 1 of 1 : FA_2015_RD2107_329_11_20150910_00003.jpg

LM Start	2.19	Rating **	A/W	Issue No.	11
LM End	2.19	Issue Type +	Ma	Location *	CR
Category	Earthen Levee			GPS Latitude/Longitude	
				Start	End
Item	Encroachments			37.762868 °	37.762868 °
				-121.309708 °	-121.309708 °
DWR ID	DWR_RD2107_01_s_2012_11				
Action/Comments					
Pipe					
Inspector Comments: Irrigation intake pipe through levee freeboard.

View of the pipe location; alignment through levee.

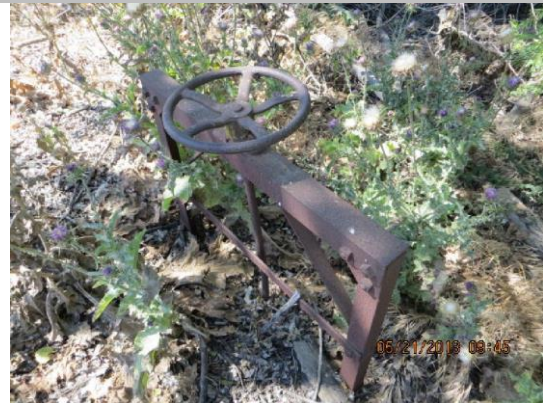
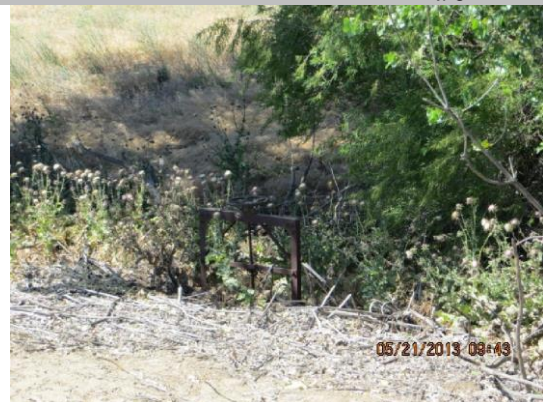
LM Start	0.27	Rating **	M	Issue No.	11
LM End	0.27	Issue Type +	En	Location *	LS
Category	Supplemental			GPS Latitude/Longitude	
				Start	End
Item	DWR UCIP Field Study			37.762613 °	37.762613 °
				-121.313480 °	-121.313480 °
DWR ID					
Action/Comments					
Inspector Comments: FS_ID:13637					
DS_ID:19057					
EP_NO: N/A					
FS_HLM: 0.263					
Repair Type: Non-Urgent					
Crossing Status: Found					
UCIP Comments: Pipe filled in with soil around outlet and not visible on					
LS. Appears abandoned and should be done so properly.					
FIELD_STRUCT_DESC: 16-inch steel storm drain pipe 16-feet below					
the crown with slide gate on WS toe. Originally included in O&M					
manual, 1964.					
FS Date: 05/21/2013

Slide gate visible on WS toe.

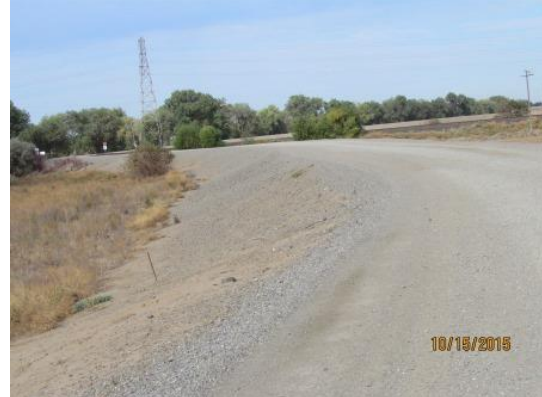
Photo 1 of 1 : FA_2015_RD2107_330_8_20151026_00005.jpg

View of the acceptable vegetation control on the waterside levee slope.

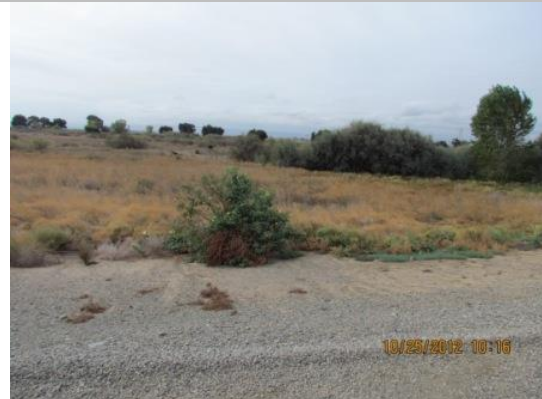
Photo 1 of 1 : FA_2015_RD2107_330_4_20150910_00001.jpg

LM Start	0.51	Rating **	M	Issue No.	4
LM End	0.51	Issue Type +	Ma	Location *	WS
Category	Earthen Levee			GPS Latitude/Longitude	
				Start	End
Item	Vegetation			37.764780 °	37.764780 °
				-121.316717 °	-121.316717 °
DWR ID	DWR_RD2107_02_s_2012_4				
Action/Comments					
Elderberries are blocking visibility and flood fight capability. Inspector Comments: Elderberry bush on waterside.

Elderberry located on waterside slope.

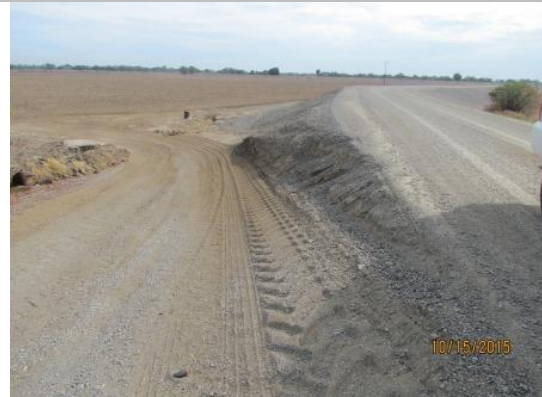
Photo 1 of 1 : FA_2015_RD2107_330_9_20151026_00006.jpg

LM Start	0.54	Rating **	M	Issue No.	9
LM End	0.54	Issue Type +	Ma	Location *	LS
Category	Earthen Levee			GPS Latitude/Longitude	
				Start	End
Item	Slope Stability			37.764838 °	37.764838 °
				-121.317318 °	-121.317318 °
DWR ID	DWR_RD2107_02_f_2015_9				
Action/Comments					
Repair slope instability.					
Inspector Comments: Add appropriate fill and compact the slope.

View of the vertical cut on the landside levee slope.

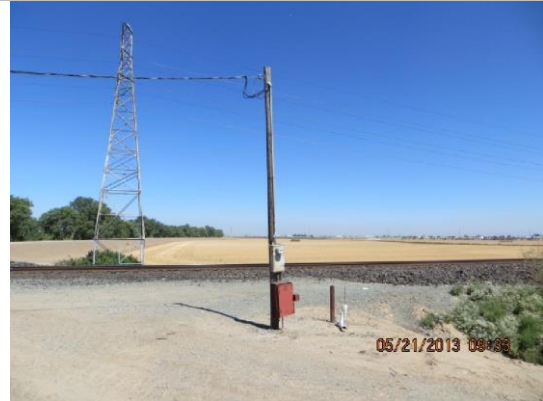
Photo 1 of 3 : UCIP_FA_2015_0351.jpg

JP and meter on LS shoulder.

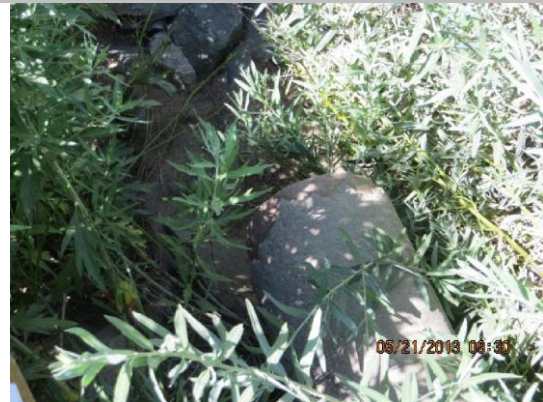
Photo 2 of 3 : UCIP_FA_2015_0352.jpg

Pipe at outlet.

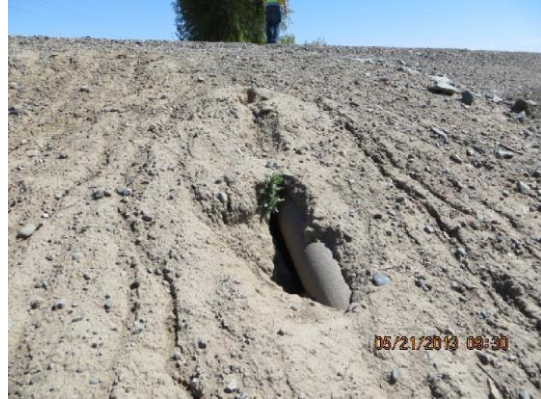
Photo 3 of 3 : UCIP_FA_2015_0353.jpg

Inspector Comments: FS_ID:13636
 DS_ID:19058
 EP_NO: 13161
 FS_HLM: 0.5426
 Repair Type: Non-Urgent
 Crossing Status: Found
 UCIP Comments: Some erosion along pipe alignment on WS slope.
 FIELD_STRUCT_DESC: 10-inch steel storm drain pipe through the levee 5-feet below the crown. Pump located on 36-inch concrete standpipe at LS toe. A PVC pipe runs parallel to waterward toe to train tracks. Air relief valve on waterward shoulder (Permit No. 13161, 1981).
 FS Date: 05/21/2013

Erosion along pipe alignment on WS slope.

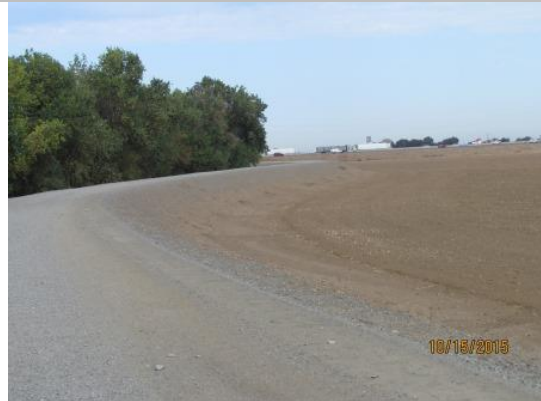
Photo 1 of 1 : FA_2015_RD2107_330_10_20151026_00007.jpg

LM Start	0.75	Rating **	A	Issue No.	10
LM End	0.75	Issue Type +	Ma	Location *	LS
Category	Earthen Levee			GPS Latitude/Longitude	
				Start	End
Item	Vegetation			37.766621 °	37.766621 °
				-121.320149 °	-121.320149 °
DWR ID	DWR_RD2107_02_f_2015_10				
Action/Comments					
Control annual grass and weeds on the levee slopes and easements.

View of the acceptable vegetation control on the landside levee slope.

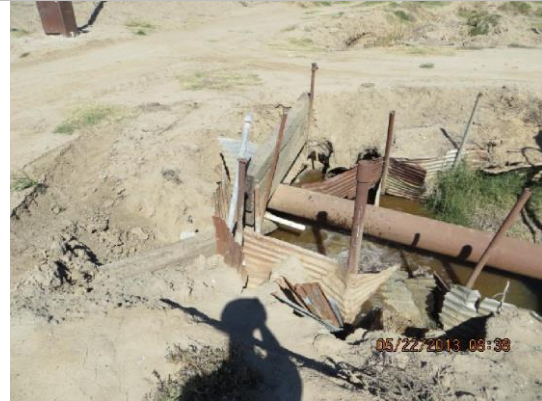
Photo 1 of 3 : UCIP_FA_2015_0173.jpg

Inspector Comments: FS_ID:43097
 DS_ID:19056
 EP_NO: 2966
 FS_HLM: 1.525
 Repair Type: Urgent
 Crossing Status: Found
 UCIP Comments: Headwall around pipe at LS toe is failing and should be shored up. Flap gate propped open and should be returned to normal function.
 FIELD_STRUCT_DESC: 24-inch steel drain pipe through the levee 14 feet below the crown. Flap gate installed on the waterward end of the pipe and two standard reinforced concrete cutoff walls were placed around the pipe in line with the levee shoulders (Permit No. 2966, 1958).
 FS Date: 05/22/2013

Headwall failing at drainage ditch on LS toe.

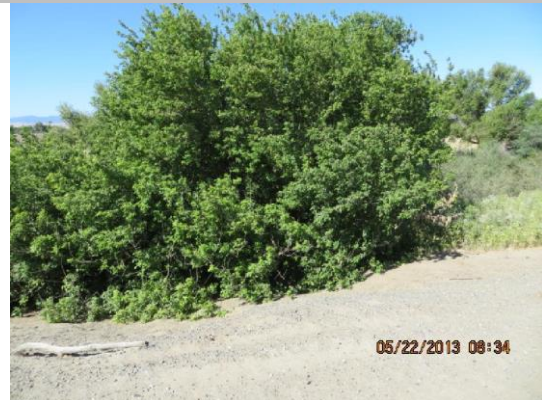
Photo 2 of 3 : UCIP_FA_2015_0174.jpg

Pipes visible under foliage on WS toe.

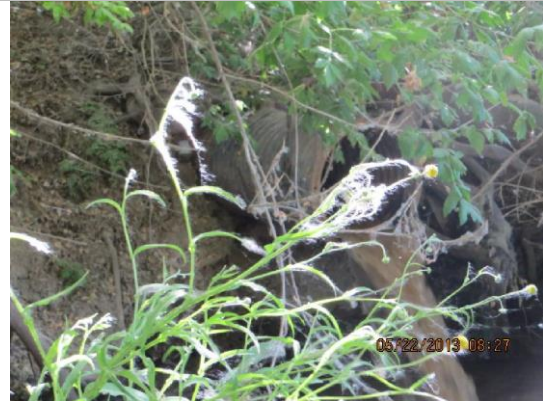
Photo 3 of 3 : UCIP_FA_2015_0175.jpg

Pipe visible on WS toe with Flap gate open.
